Revision Guide for AMD Family 15h Models 00h-0Fh Processors

Publication # 48063	Revision: 3.00
Issue Date: October 2011

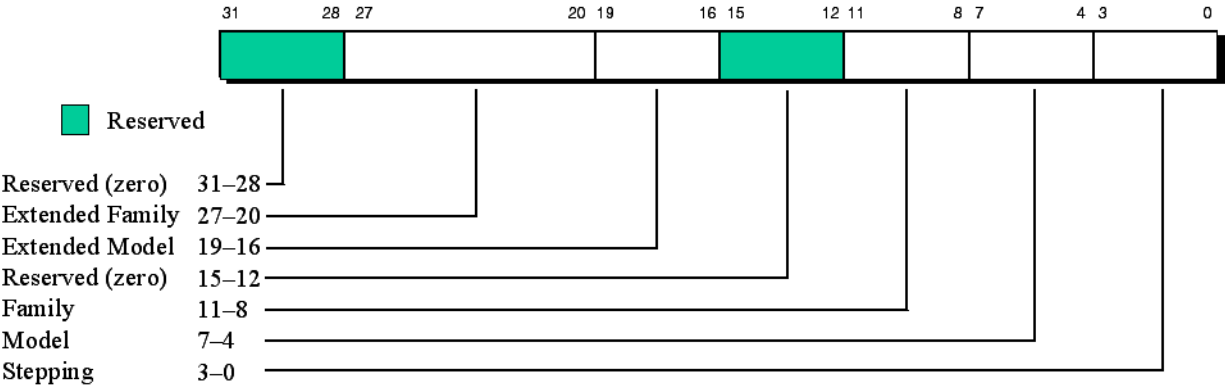
Figure 1. Format of CUID Fn0000_0001_EAX

A processor revision is identified using a unique value that is returned in the EAX register after executing the CUID instruction function 0000_0001h (CUID Fn0000_0001_EAX). [Figure 1](#) shows the format of the value from CUID Fn0000_0001_EAX. In some cases, two or more processor revisions may exist within a stepping of a processor family and are identified by a unique value in D18 F4x164 Fixed Errata Register (see [D18F4x164 Fixed Errata Register](#)).
